## BEHAVIOR OF FLOORING

### Moisture

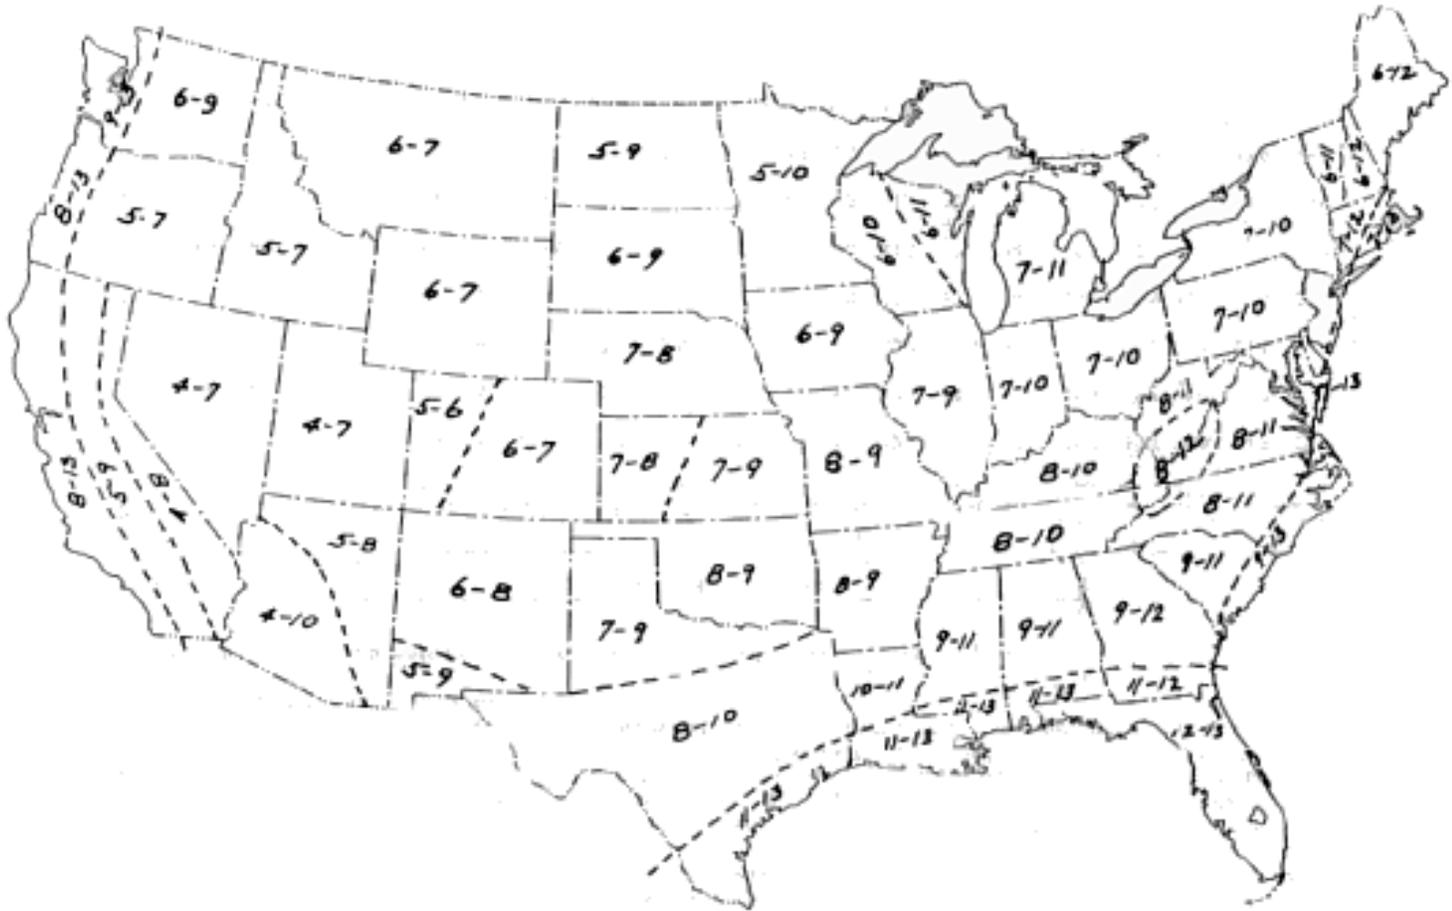
The Moisture Content Map shows average interior moisture contents in winter and summer by geographic areas. In each pair of figures, the first is average moisture content during January and the second is average moisture content during July for wood products used indoors. For instance, flooring installed in buildings along the Gulf Coast is expected to eventually acclimate between 11% and 13% moisture content. Also, flooring installed in the Western Rockies can be expected to eventually acclimate between 4% and 8% moisture content.

Moisture Content Map, from the US Department of Agriculture, Forest Products Laboratory

The moisture contents shown in the map are based on the average seasonal conditions. Excessively dry or excessively wet conditions can further influence the changing moisture content of flooring. Also Interior environmental controls that continually provide stable temperature and relative humidity will reduce the change of MC% of flooring. Other influencing factors can be excessively wet or excessively dry materials in contact with the wood flooring both during distribution and at the job site.
